# RESULTS OF THE FIRST UNITED STATES MANNED ORBITAL SPACE FLIGHT

FEBRUARY 20, 1962

Manned Spacecraft Center  
NATIONAL AERONAUTICS AND SPACE ADMINISTRATION

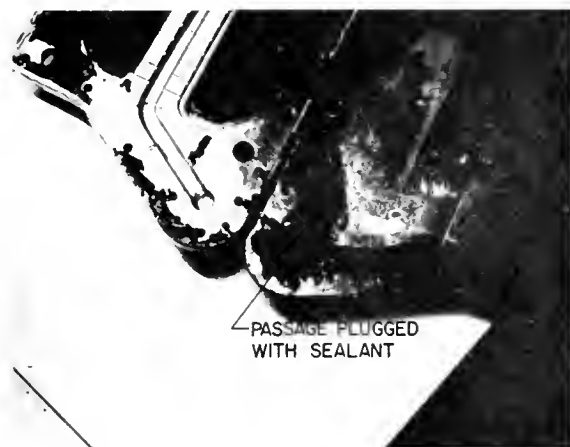
FIGURE 5-16.—Plugged inlet part of cooling plate for 150 v-amp inverter.

verter remained cool. A subsequent investigation indicated that the flow passages in the water-type heat exchanger (cooling plate) were plugged. It was found that sealant used in the construction of the cooling plates had penetrated into the flow passages as shown in figure 5-16. The passages were cleaned and the original orifices were reinstalled. Flow tests on the final installation showed that the system was clean.

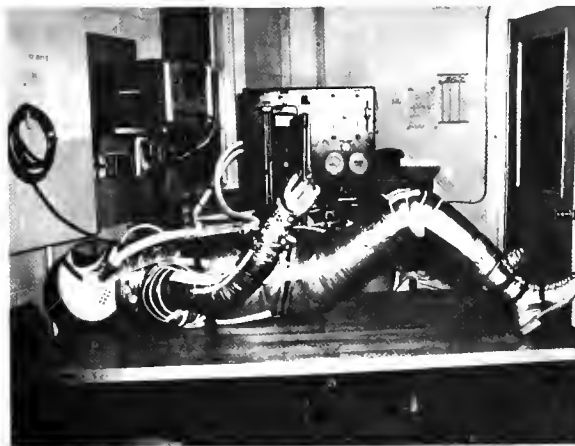
FIGURE 5-25.—Pressure tests of astronaut's pressure suit at 5 psi.

After a detailed analysis of the system it was concluded that there must be a leak in the astronaut's pressure suit. Prior to any test involving the suit, it was pressure tested at 5 psi (fig. 5-25). However, the suit, during normal

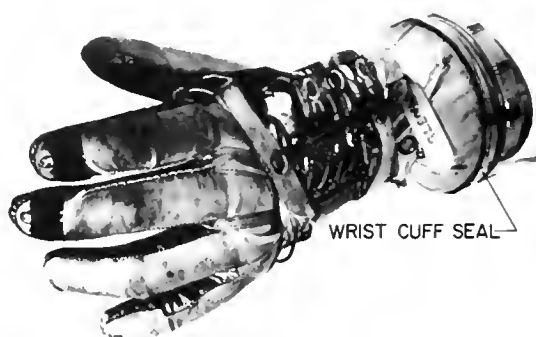
FIGURE 5-27.—Pressure-suit gloves showing cuff slip joint.

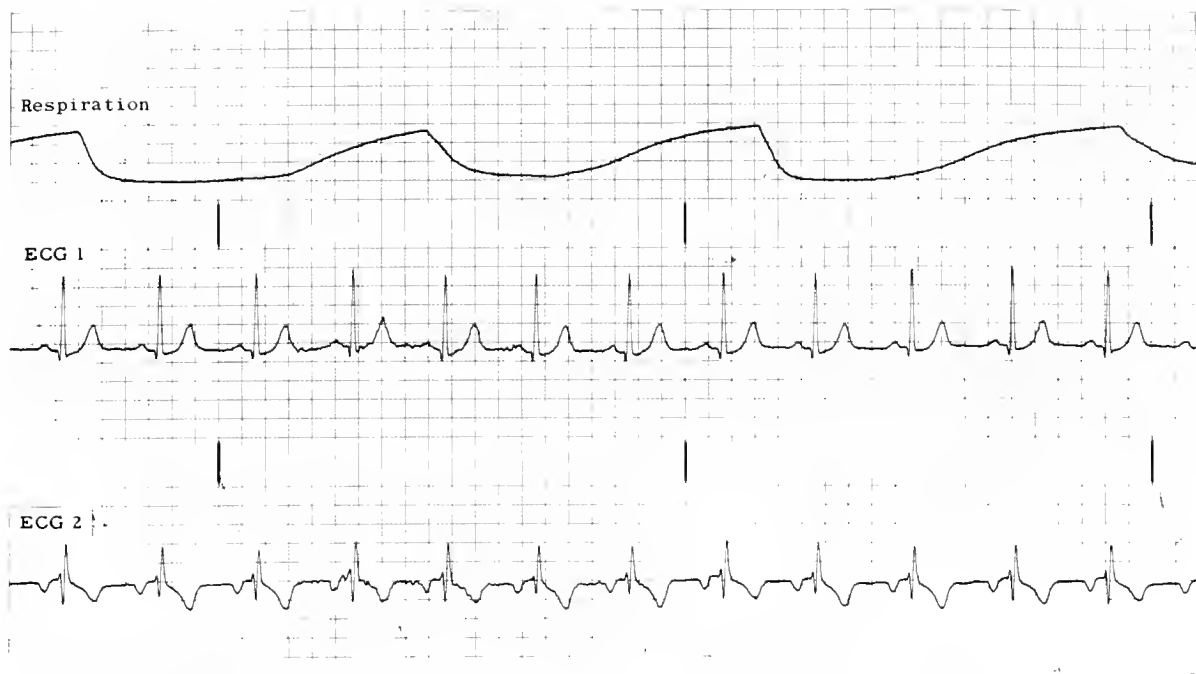
FIGURE 9-2.—Sample of blockhouse physiological record at insertion, 6:06 a.m. e.s.t. Lead 2 is inverted.  
(Recorder speed 25 mm/sec).

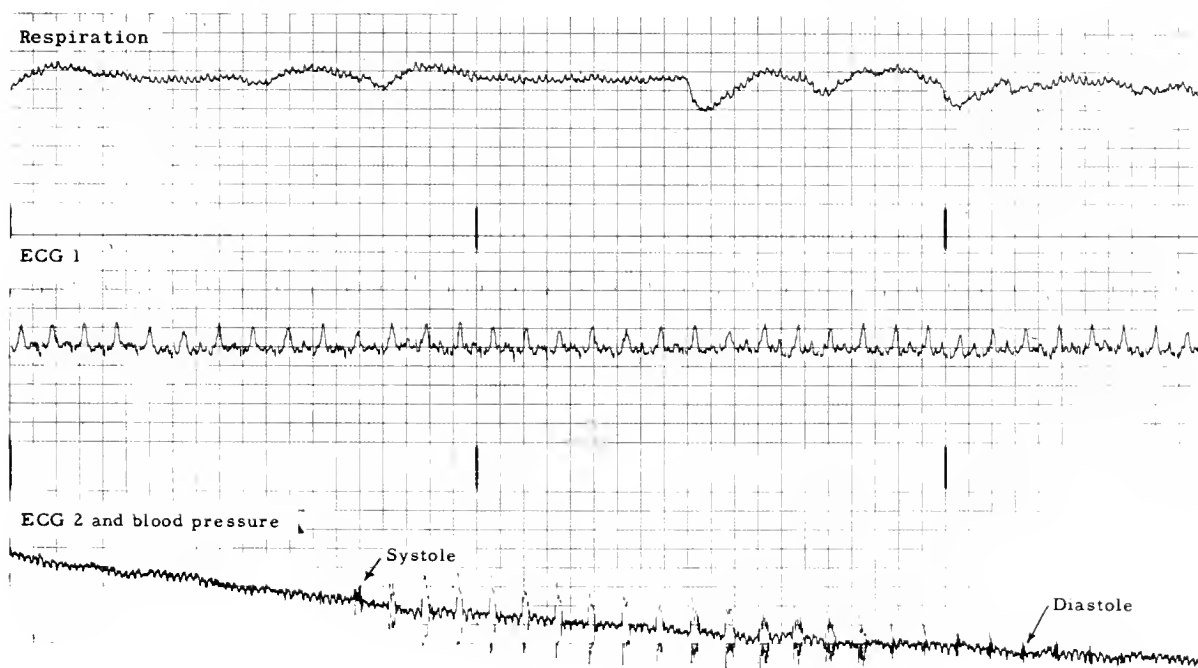
FIGURE 9-7.—Sample of playback record from the onboard tape showing physiological data after 2 hours and 53 minutes of weightlessness, with inflight blood pressure trace, value of 135/64. (Recorder speed 10 mm/sec).

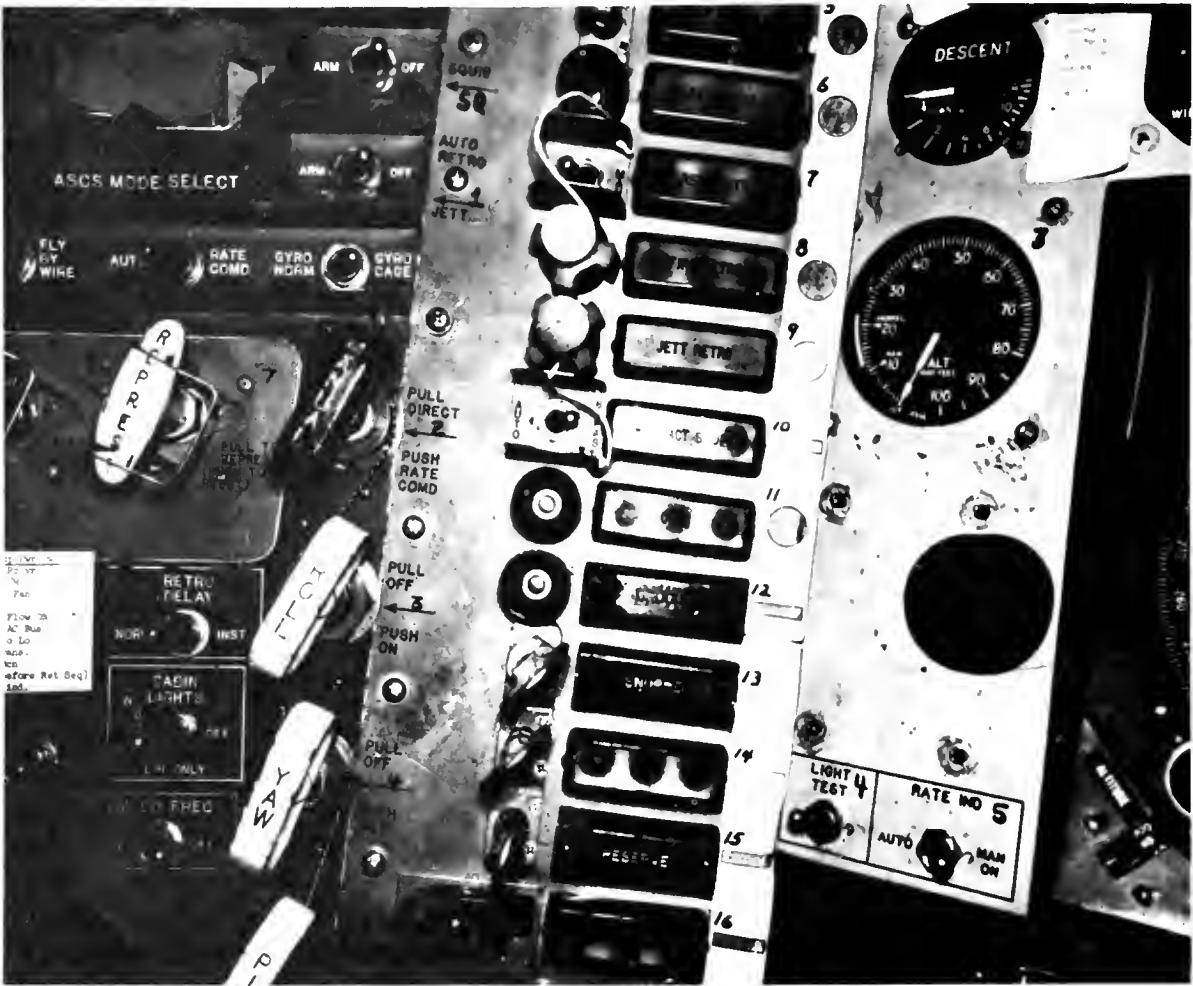
FIGURE 11-1.—MA-6 instrument panel, left section.

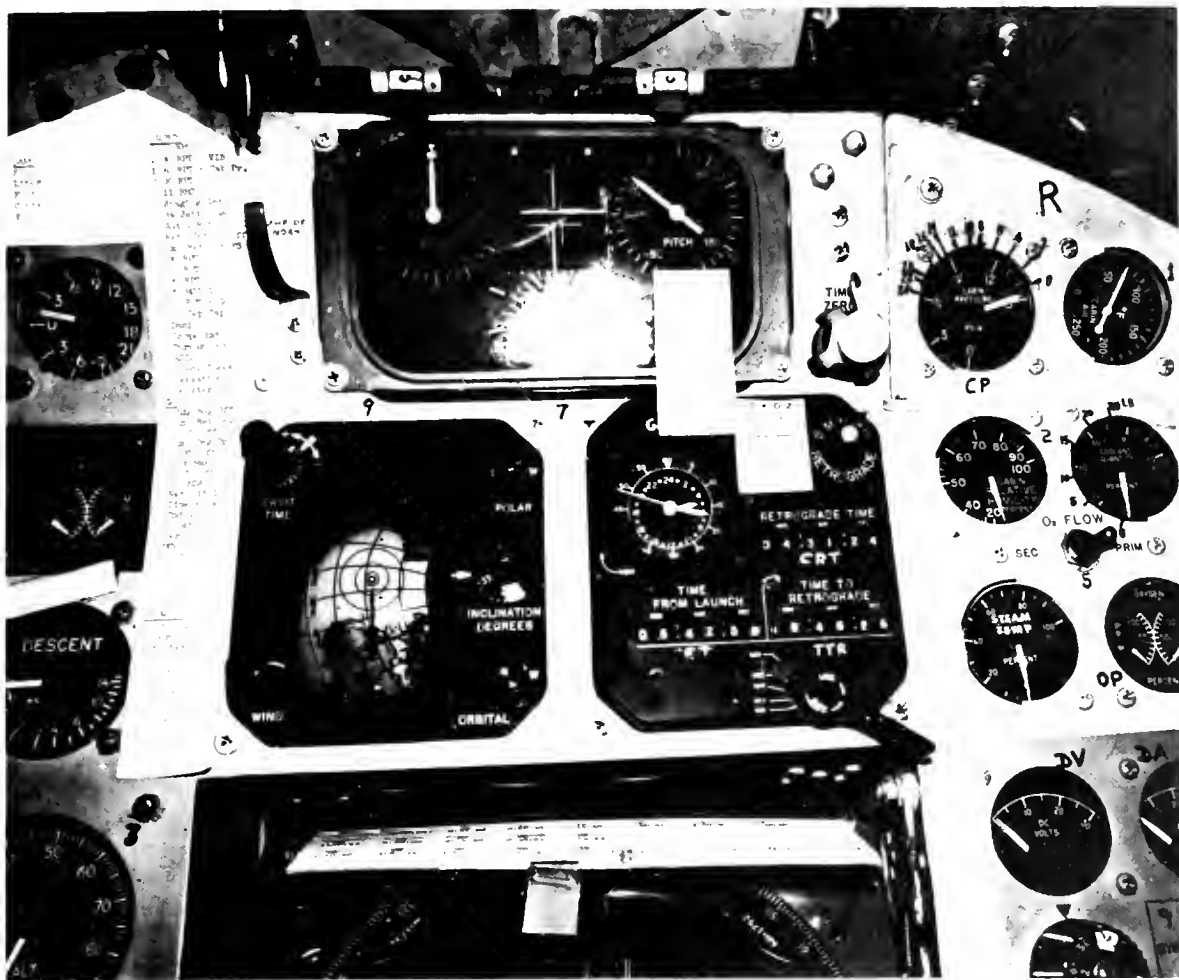
FIGURE 11-2.—MA-6 instrument panel, center section.

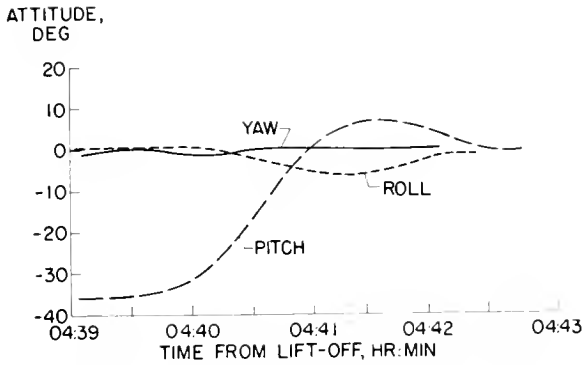
FIGURE 11-5.—MA-6 reentry pitch maneuver.
